KINGSTON UNDERPASS

FLOOD RISK INVESTIGATION – ADDENDUM TO KINGSGATE ROAD RAILWAY BRIDGE FLOOD INVESTIGATION REPORT, 2013

PREPARED FOR ROYAL BOROUGH OF KINGSTON

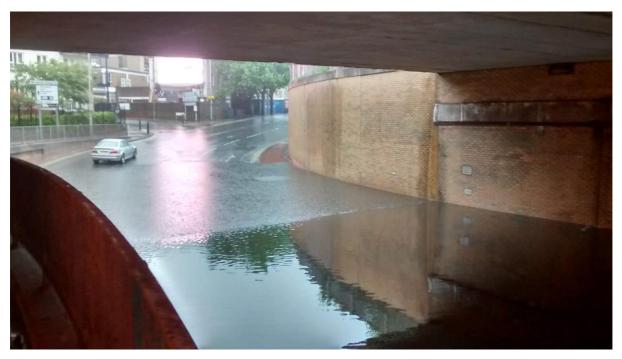
Flooding of the underpass led to closure of the highway in the affected area and diversion of traffic in Kingston town centre. Kingston bridge (located over the River Thames, over 400m to the south west of the site) was also closed to prevent high sided vehicles from entering the diversion route in the town centre. Various local news websites confirmed that there was traffic disruption and delays within Kingston. Video clips on social media show members of the public pushing a vehicle out of the floodwater. Anecdotal evidence says that at the deepest point, the depth of flood water was greater than six feet. During the flood incident, the TWUL pumping station located close to the site failed (see *Chapter 4.3.2* for further details). Once the water had been removed, Kingston arranged for two abandoned vehicles to be removed. The highway was cleansed and re-opened in time for the morning rush hour on 11th July 2020. Photographs of the flooding incident are shown in *Figures 2.1* and *2.2*.

Figure 2.1 Flooding at the Kingston underpass site on 10th June 2019. Source: Kingston

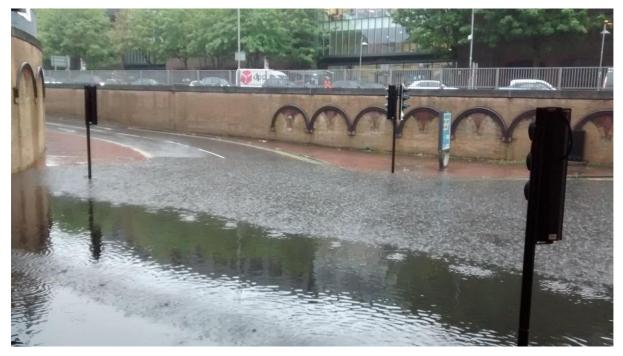
Figure 2.2. Flooding at the Kingston underpass site on 10th June 2019. Source: Kingston

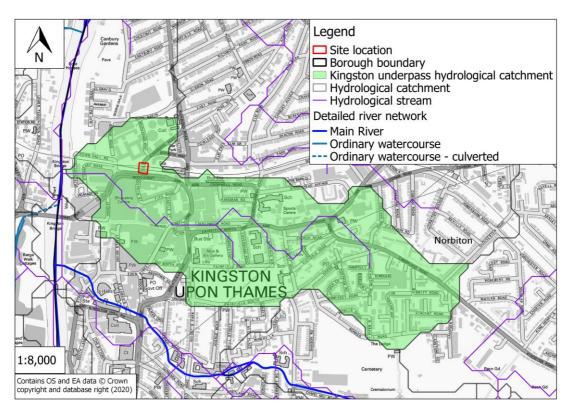
Analysis of the area provided several outputs, including a defined hydrological catchment and a primary overland flow path for water (shown as 'Hydrological Stream' in *Error! Reference source not found.*). The Kingston underpass site is situated close to the primary flow path in the catchment. This means that runoff from the topographically higher surrounding areas may flow towards the site and contribute to the surface water that reaches the site. The primary flow path is represented as the main overland flow route for surface water in the catchment. The topography indicates that rain falling on this catchment will flow from the north and east towards the River Thames. Further hydrological catchment and primary flow path (defined as the 'hydrological stream') information is presented in *Figure 3.1.*

Figure 3.1 Hydrological catchment and primary flow path for the Kingston underpass site

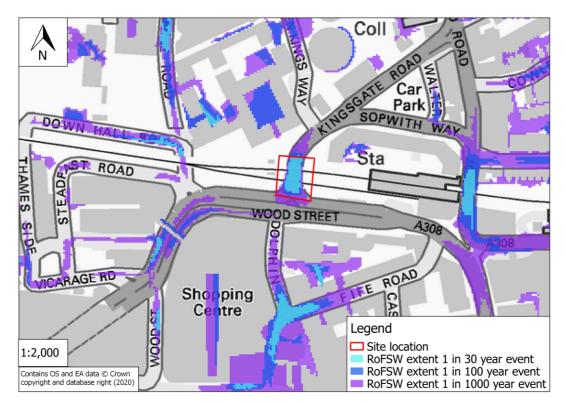
The EA's Risk of Flooding from Surface Water (RoFSW) map shows the site to be at risk of surface water flooding from the 1 in 30, 1 in 100 and 1 in 1000 year rainfall events. The previous flood events in July 2013 were attributed to surface water flooding. The RoFSW map is shown in *Figure 3.2*. The urbanised nature of the area surrounding the site exacerbates the risk of flooding from surface water, as there is little infiltration potential for runoff to seep into the largely impermeable ground.

Figure 3.3 Risk of flooding from surface water at the Kingston underpass site

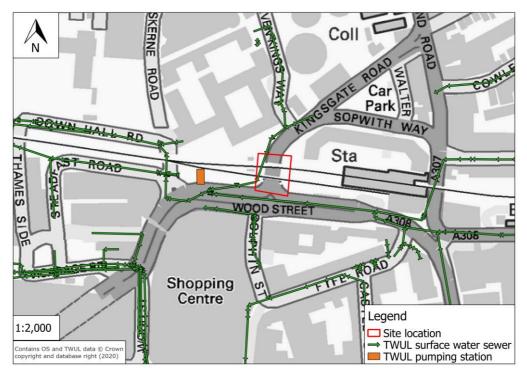
There is historical evidence that the TWUL pumping station located close to the Kingston underpass site has failed on several previous occasions. Water from the surrounding area drains through the sewer network to a 30m deep sump located next to the pumping station. Water is then pumped through a rising main before entering a gravity drained sewer which carries flows towards the River Thames. Failure of the pumping station leads to blockages and a reduction in capacity of the sewer network. As the Kingston underpass is the lowest topographical point in the vicinity, it is at increased risk of sewer flooding. The location of the TWUL pumping station and surface water sewer network are shown in *Figure 3.3*.

Figure 3.4 TWUL surface water sewer system and pumping station

The 2013 *Kingsgate Road Railway Bridge Flood Investigation Report* states that the TWUL pumping station failed during the 2013 flood event. Due to this history of failure and the fact that TWUL had to re-start the pumps for the June 2019 event, it is concluded that the pumping station failed during the June 2019 event also.

- Further investigate and liaise with TWUL to determine if any action has been taken to prevent failure of the pumping station in the future, and produce an action plan which can be implemented if the pumping station fails again.
- Continue to collaborate with TWUL on the DWMP investigations, to address flooding within the area.
- In the event of future flooding, investigate opportunities for introducing automated traffic diversions, signage, and alarms.
- Review the measures put in place following the 2013 *Kingsgate Road Railway Bridge Flood Investigation Report.*

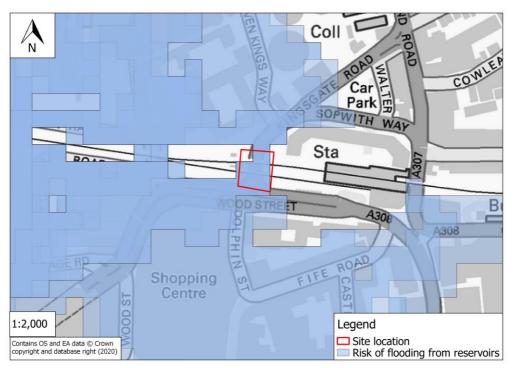
There are no artificial watercourses within the vicinity of the site. The EA's *Risk of Flooding from Reservoirs* map shows the site to be at risk of flooding from reservoirs (see *Figure 3.4*). However, there were no reservoir flood incidents that occurred at the time of the flood event. The nearest reservoir to the site is the Island Barn Reservoir, located approximately 4.5km to the south west. It is therefore unlikely that this flooding incident can be attributed to reservoir flood sources.

Figure 3.5 EA Risk of Flooding from Reservoirs extent

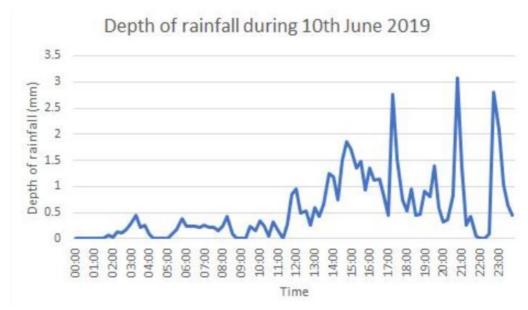
The data for the June 2019 event indicates that the peak rainfall return period for this event approximates to a 1 in 5-year event (20% probability of rainfall of that intensity occurring each year). As the Kingston underpass is located at a local topographical low point, rainwater ponds at the site during flood events. Based on the severity of the flood event which occurred, the amount of water captured in the TBR is not as expected considering the nature of the recorded flood event. It is therefore possible that the flood event is greater than the 1 in 5-year event. The proximity of the Hogsmill TBR to the Kingston underpass site makes it the best TBR data source to approximate the rainfall return period for the catchment. The next nearest TBR to the site is located approximately 4.3km to the north west in Fulwell.

Figure 3.7 Rainfall depth on 10th June 2019
