Land off Cambridge Road, Kingston upon Thames, KT1 3HY

## Ground Investigation Report

**Project Title:** Phase 1 Cambridge Road  
**Location :** Cambridge Road, Kingston upon Thames  
**Project No. :** GE18530  
**Client :** Cambridge Road (RBK) LLP

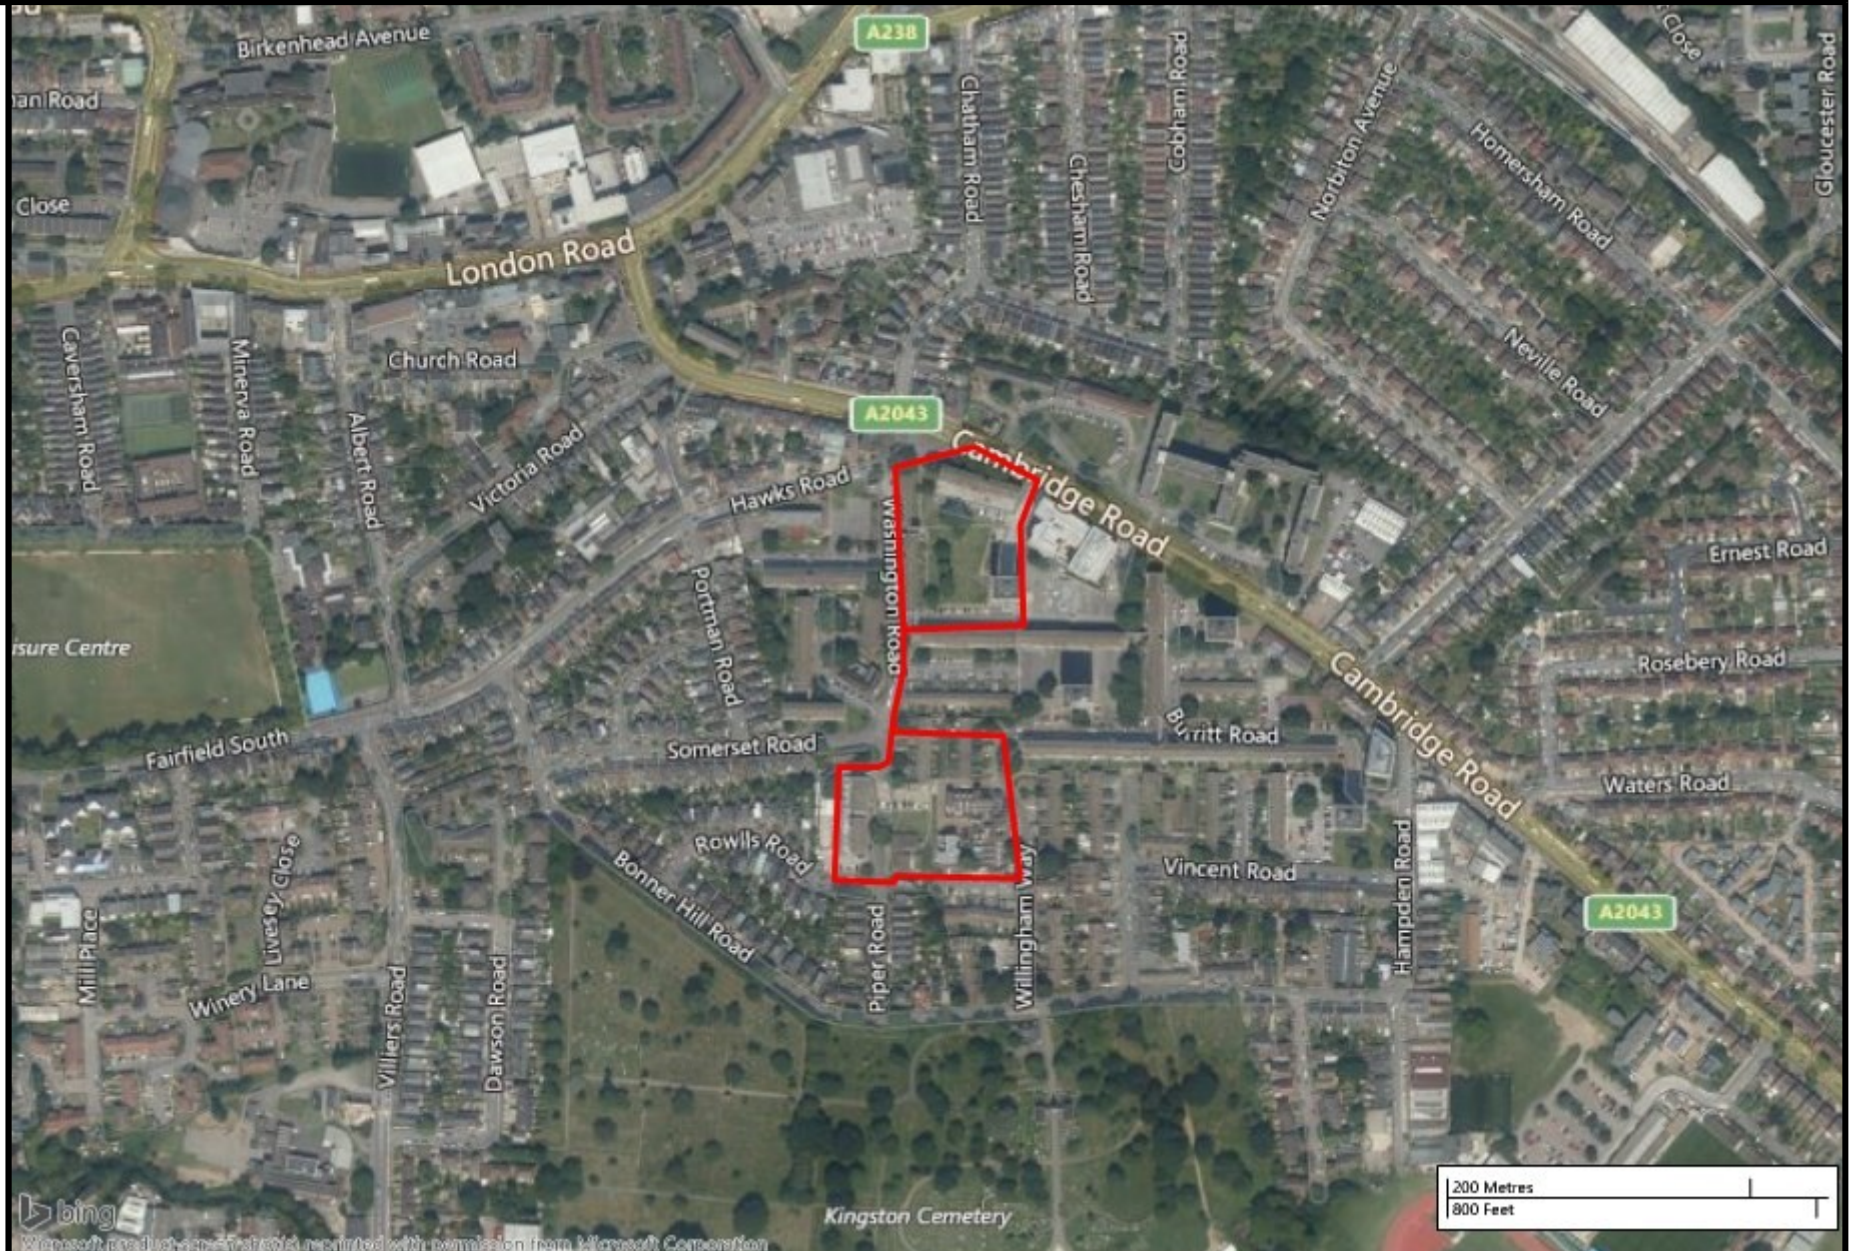
**Title :** Figure 2 - Exploratory Hole Location Plan  
**Scale:** 1:2000  
**Engineer:** JT

- Construction of 18No. dynamic sampler boreholes to depths of up to 4m bgl, depending on drilling conditions, using a self-propelled track mounted rig.
- Supervision by a UXO engineer during the drilling of the boreholes.
- Installation of 4No. groundwater and ground gas monitoring wells to depths of 3m.
- One ground gas monitoring (spot monitoring) visit.
- Geochemical laboratory testing on soils and water for a suite of commonly occurring brownfield contaminants and asbestos screening
- Waste categorisation testing on soil samples to aid the assessment of likely waste classification of surplus soils.
- Waste Acceptance Criteria (WAC) testing on selected samples representative of soils to be removed from site for disposal as waste.
