CDA 016 OLD MALDEN

CDA 017 KING GEORGE'S TRADING ESTATE

CDA 018 HOOK KELVIN GROVE

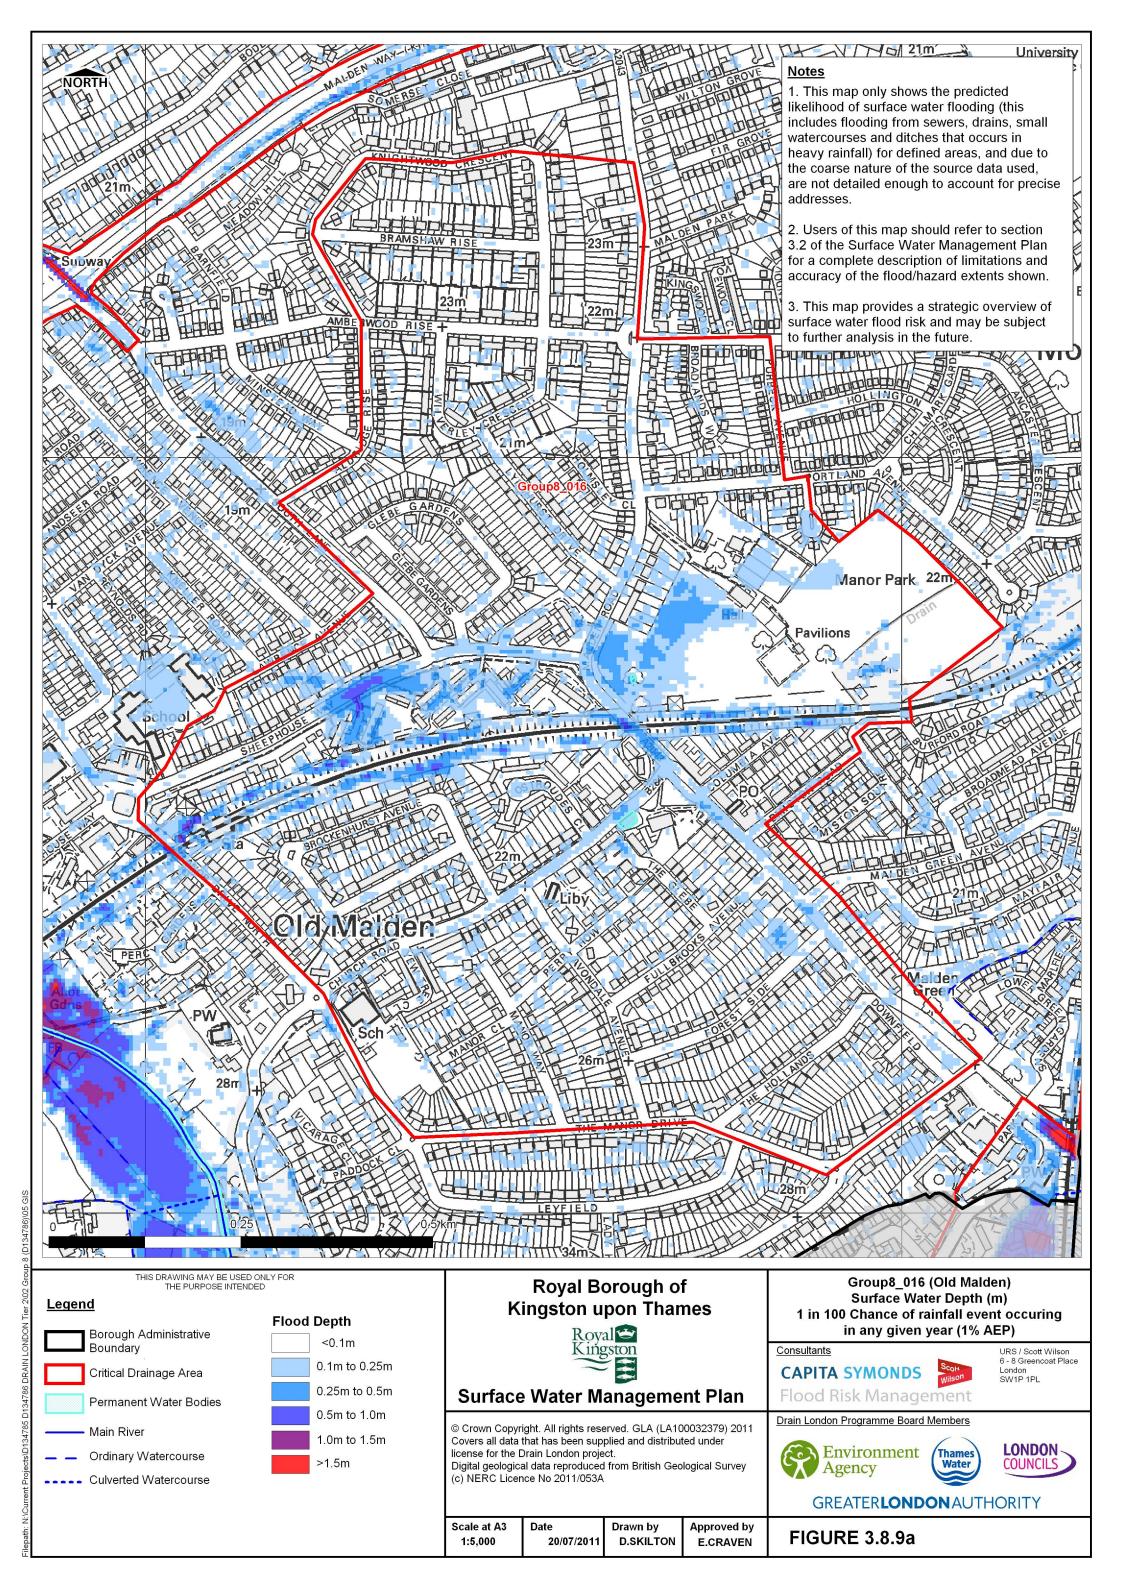
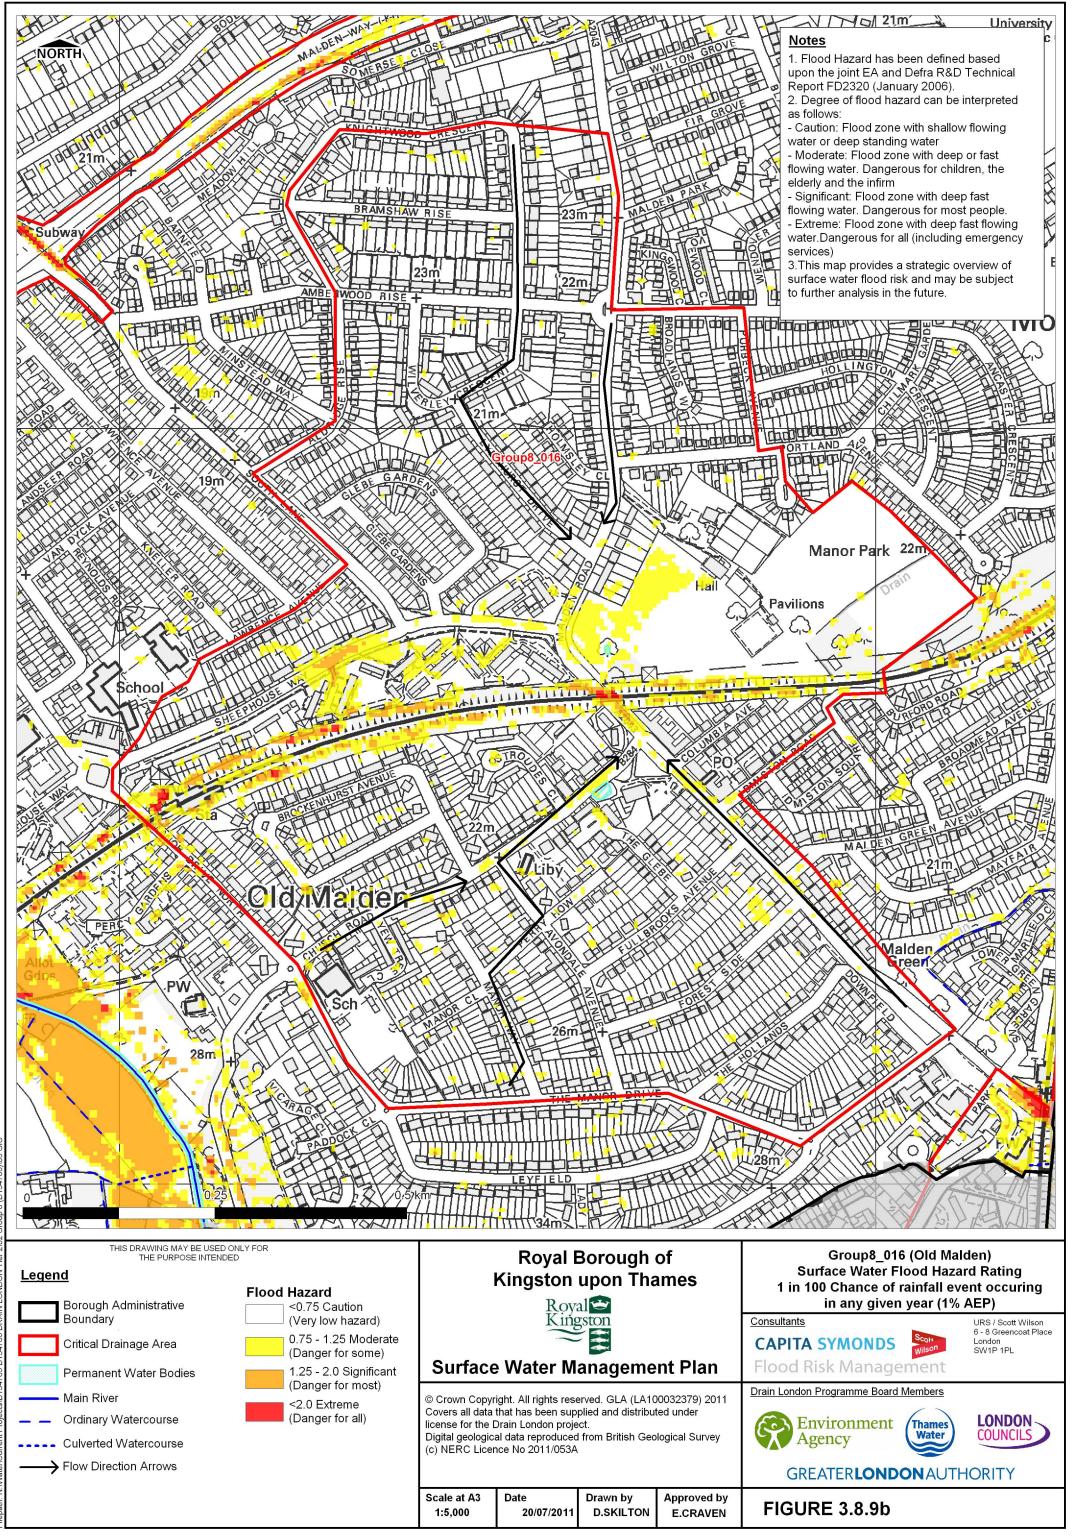
• 0 non deprived households with basements are identified	
	with basements are identified to be at risk of flooding to a	
	to be at risk of flooding to a depth >0.5m	
	depth > 0.03m	
	There are no deprived households identified as being at risk within the	
	CDA	
Critical	There are no pieces of critical infrastructure identified within this CDA	
Infrastructure		
Validation	The Council do not have any records of surface water flooding at this	
	location.	
Figures	Figure 3.8.9a – Surface Water Depth (1% AEP)	
	Figure 3.8.9b – Surface Water Flood Hazard (1% AEP)

- 3.8.28 CDA-016 is located in the east of the Borough. Surface water flows from the north and south towards the centre of this CDA where flooding is shown along Sheephouse Way and Malden Road, with peak depths experienced at the rail bridge crossing. A large extent of flooding within this CDA is contained within Manor Park.
- 3.8.29 Thames Water DG5 records identify the CDA as being located within a post code boundary with 1-5 records of sewer flooding (Figure D-5).
- 3.8.30 The CDA is not identified as being at risk of groundwater flooding, and the Environment Agency has no records of groundwater flooding at this location (Figure 3).

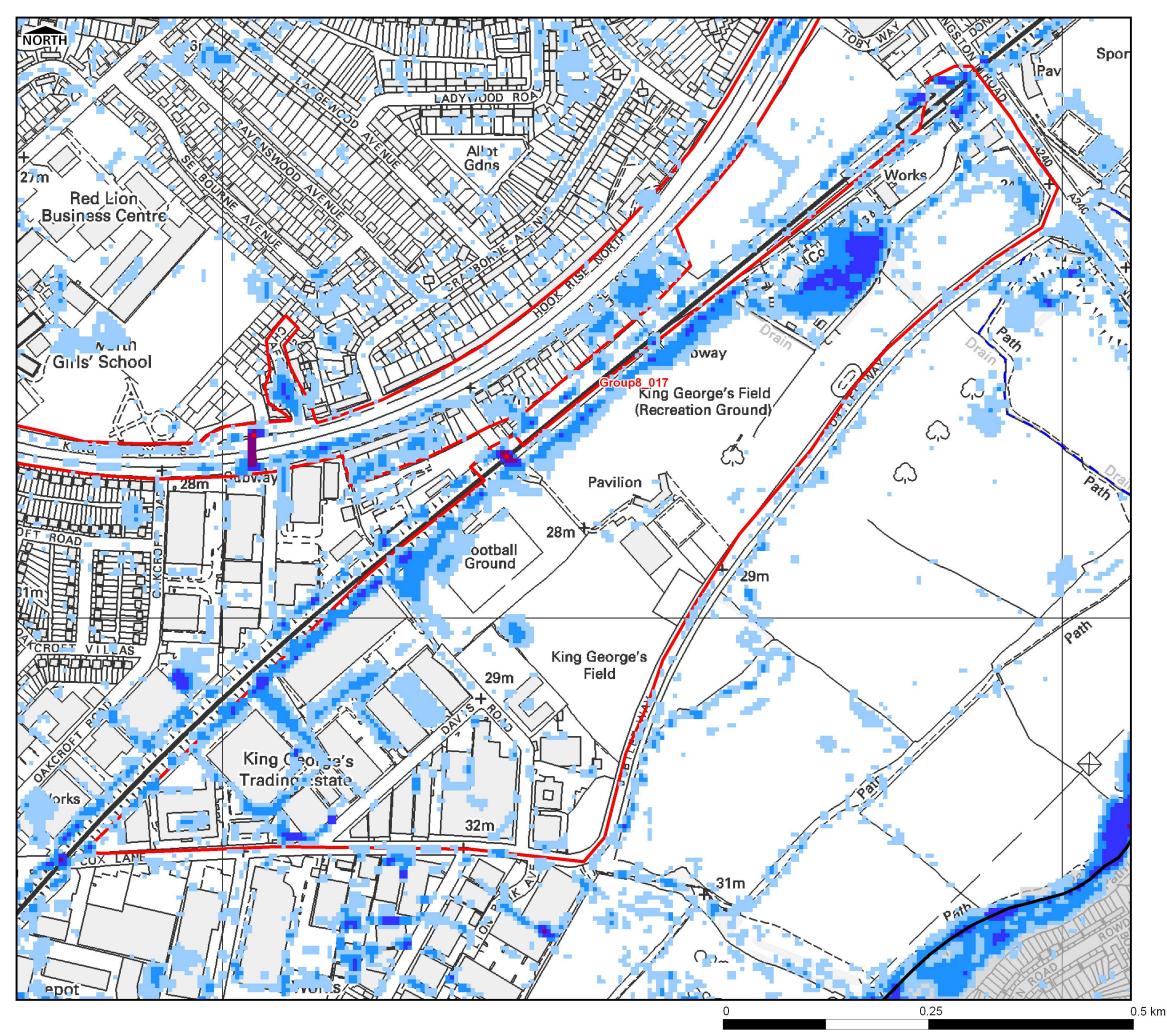
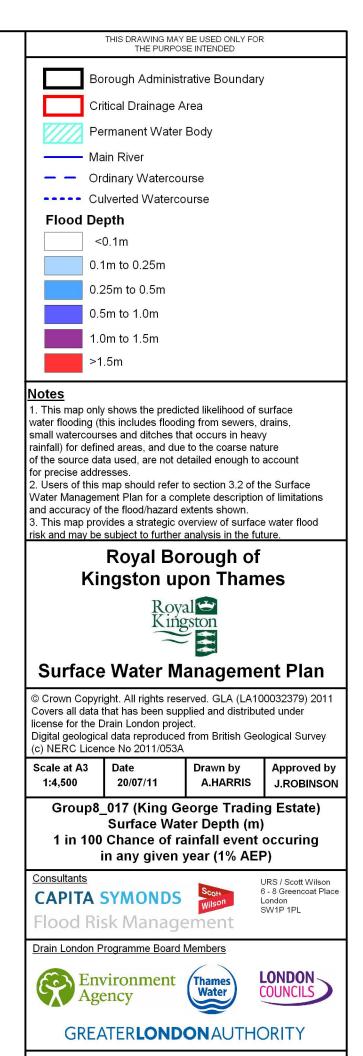
FIGURE 3.8.10a

• 0 non deprived households	• 0 non deprived households	
	with basements are identified	with basements are identified	
	to be at risk of flooding to a	to be at risk of flooding to a	
	depth > 0.03m	depth >0.5m	
	There are no deprived households	identified as being at risk within the	
	CDA		
Critical	There are no pieces of critical infrastructure located within this CDA		
Infrastructure			
Validation	The Council do not have any records of flooding at this location		
Assumptions /	The low property count reflects that this CDA contains light industrial		
Comments	uses rather than residential property.		
Figures	Figure 3.8.10a – Surface Water Depth (1% AEP)		
	Figure 3.8.10b – Surface Water Flood Hazard (1% AEP)

- 3.8.31 This CDA is located towards the south of the Borough and contains the King George Trading Estate. Surface water from the Trading Estate flows in a north westerly direction and pluvial modelling has identified pooling behind the rail embankment. The Bus Depot located on Kingston Road is shown to be located within a LFRZ.
- 3.8.32 The Borough does not have any records of flooding at this location and the CDA is not identified as an area prone to flooding by Network Rail. The surface water drainage network within the Trading Estate is privately owned and maintained, connecting to Thames Water's network in Cox Lane.
- 3.8.33 The CDA is identified as being at risk of elevated groundwater levels, however the Environment Agency do not have any records of groundwater flooding at this location. Thames Water DG5 records show 11-20 records of sewer flooding in the local post code area.

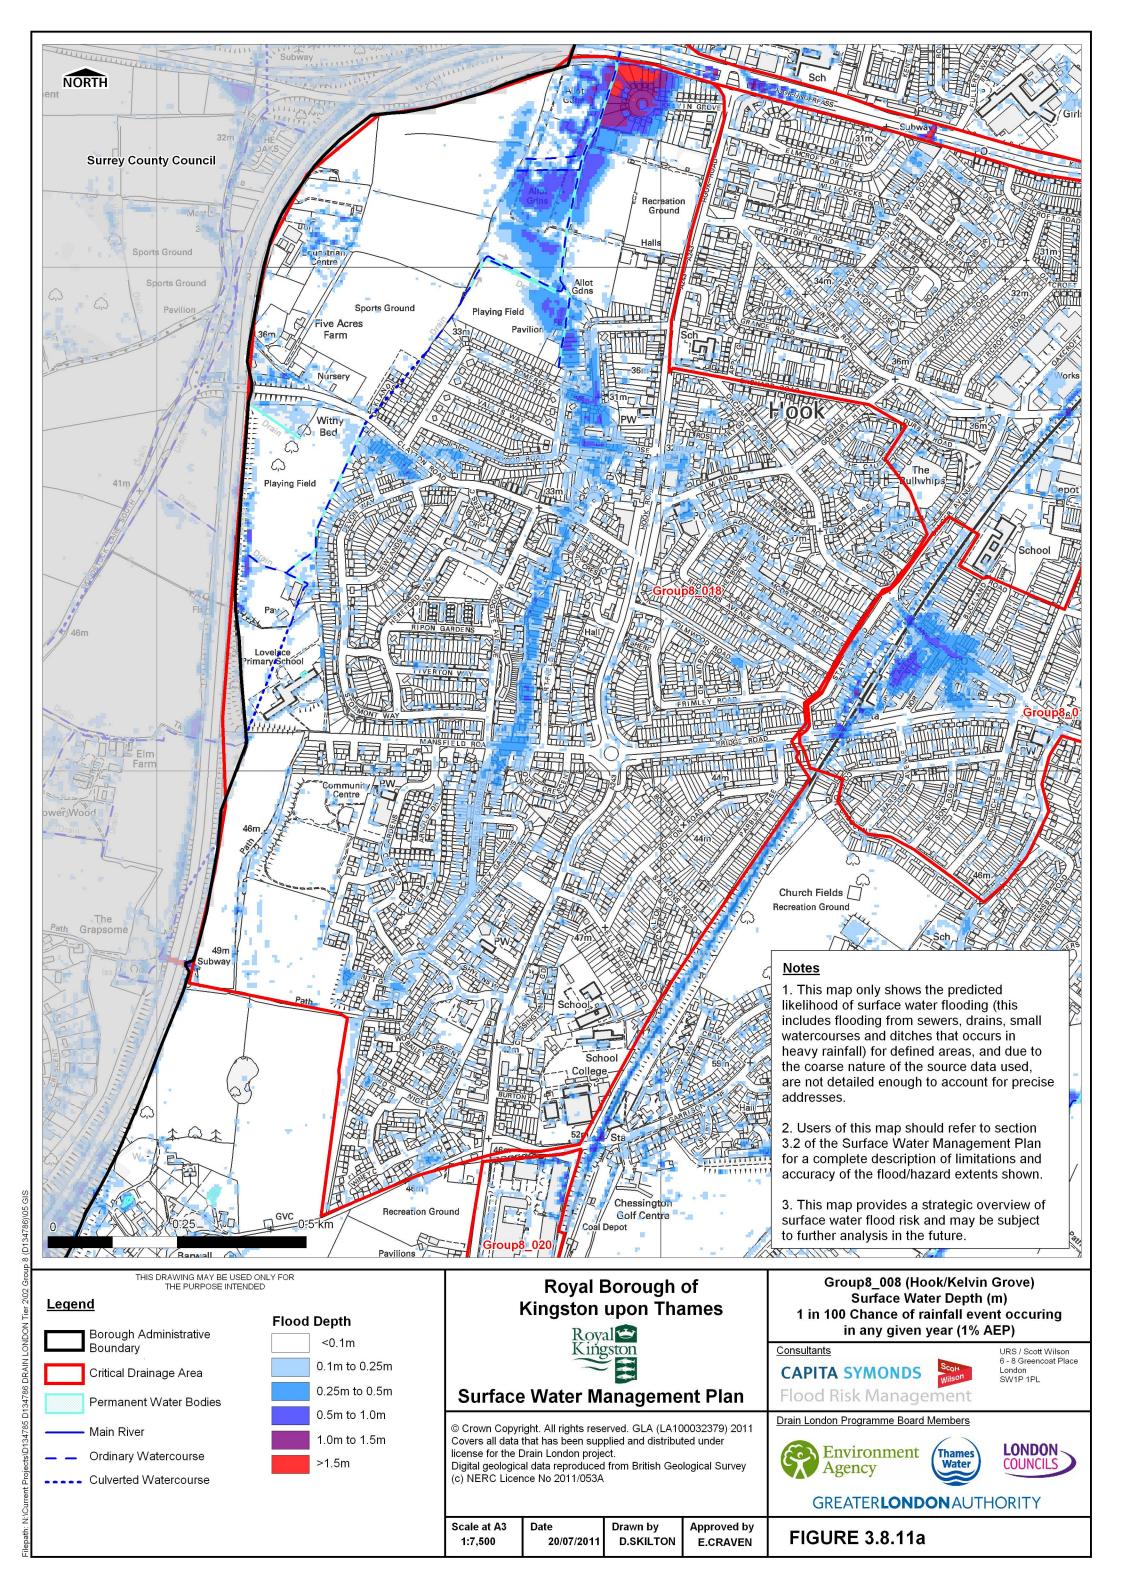
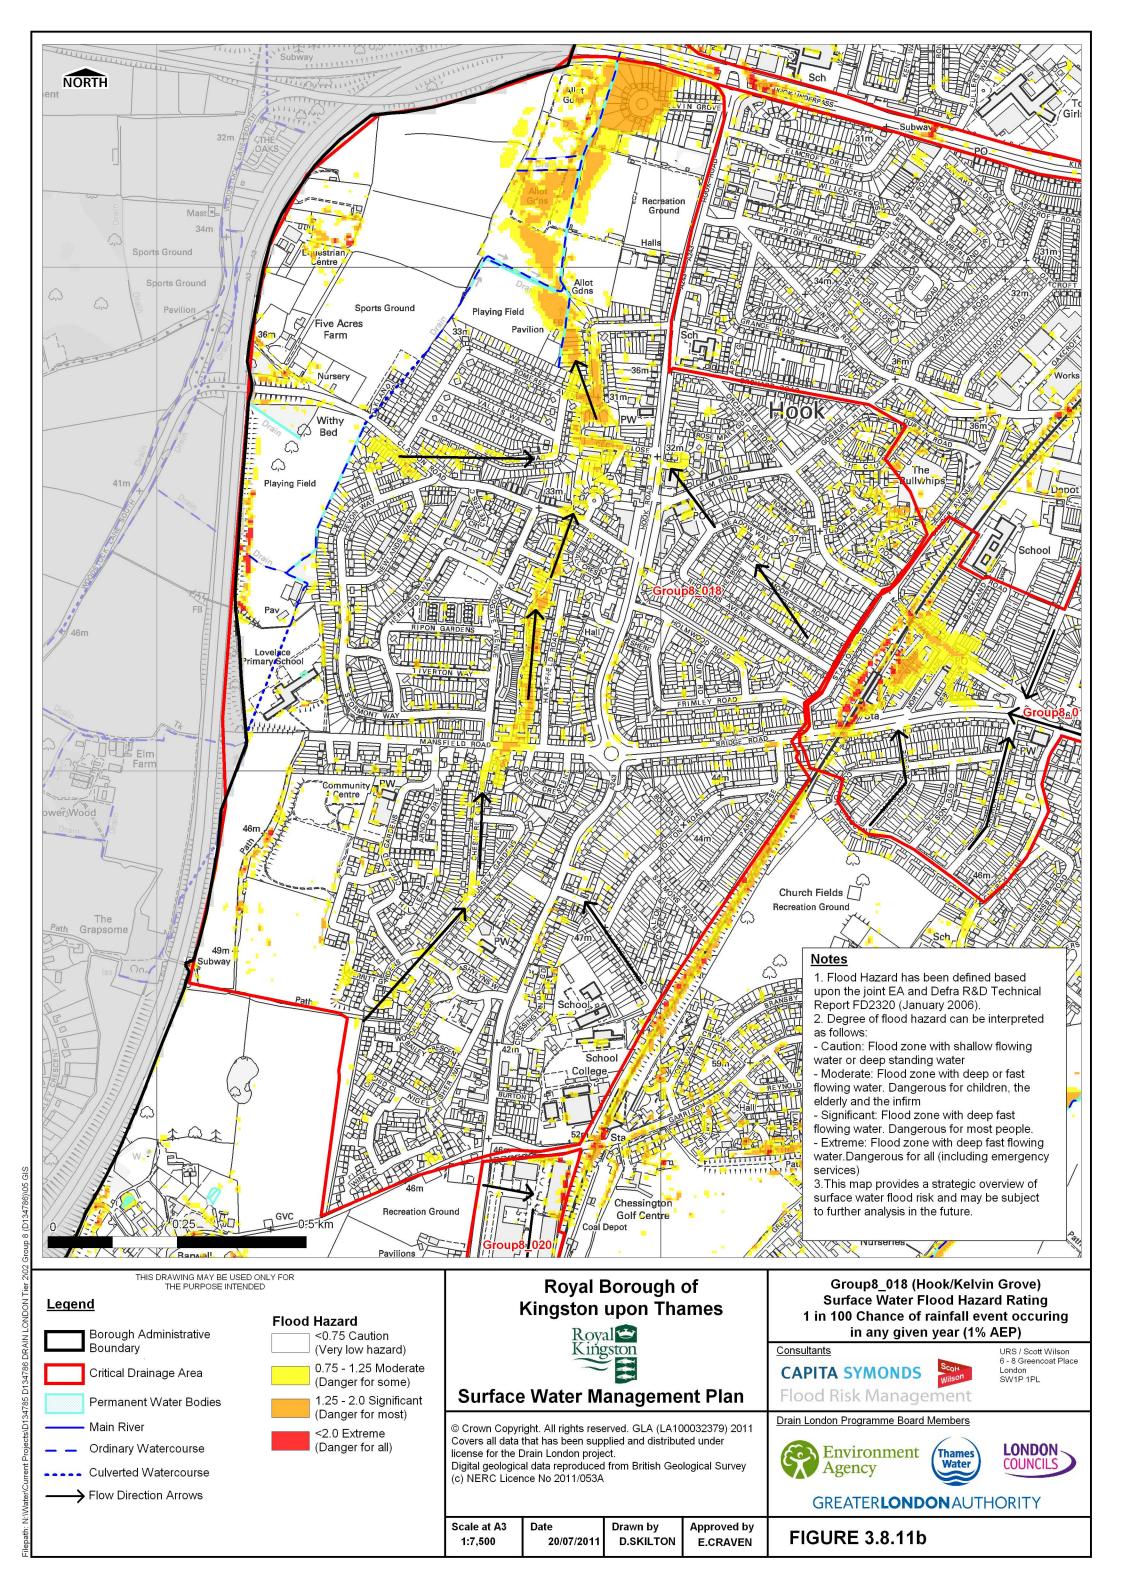
Validation	The Council have known flooding problems in fields near to Woodall		
	Close where there is a grate and culvert feature in the vicinity of the		
	Thames Water CSO outfall		
Figures	Figure 3.8.11a – Surface Water Depth (1% AEP)		
	Figure 3.8.11b – Surface Water Flood Hazard (1% AEP)

- 3.8.34 This CDA is located in the south west of the Borough, within the upper catchment of the Surbiton Stream. The north of the CDA including part of Kelvin Grove is located within the Environment Agency Flood Zone 3 outline. Pluvial modelling has also identified three overland flow paths leading towards drainage channels in the playing fields located to the north. These include Sussex Gardens/Hartfield Road to the south, Clayton and Selwood Road to the west and Moorfield/Elm Road to the east.

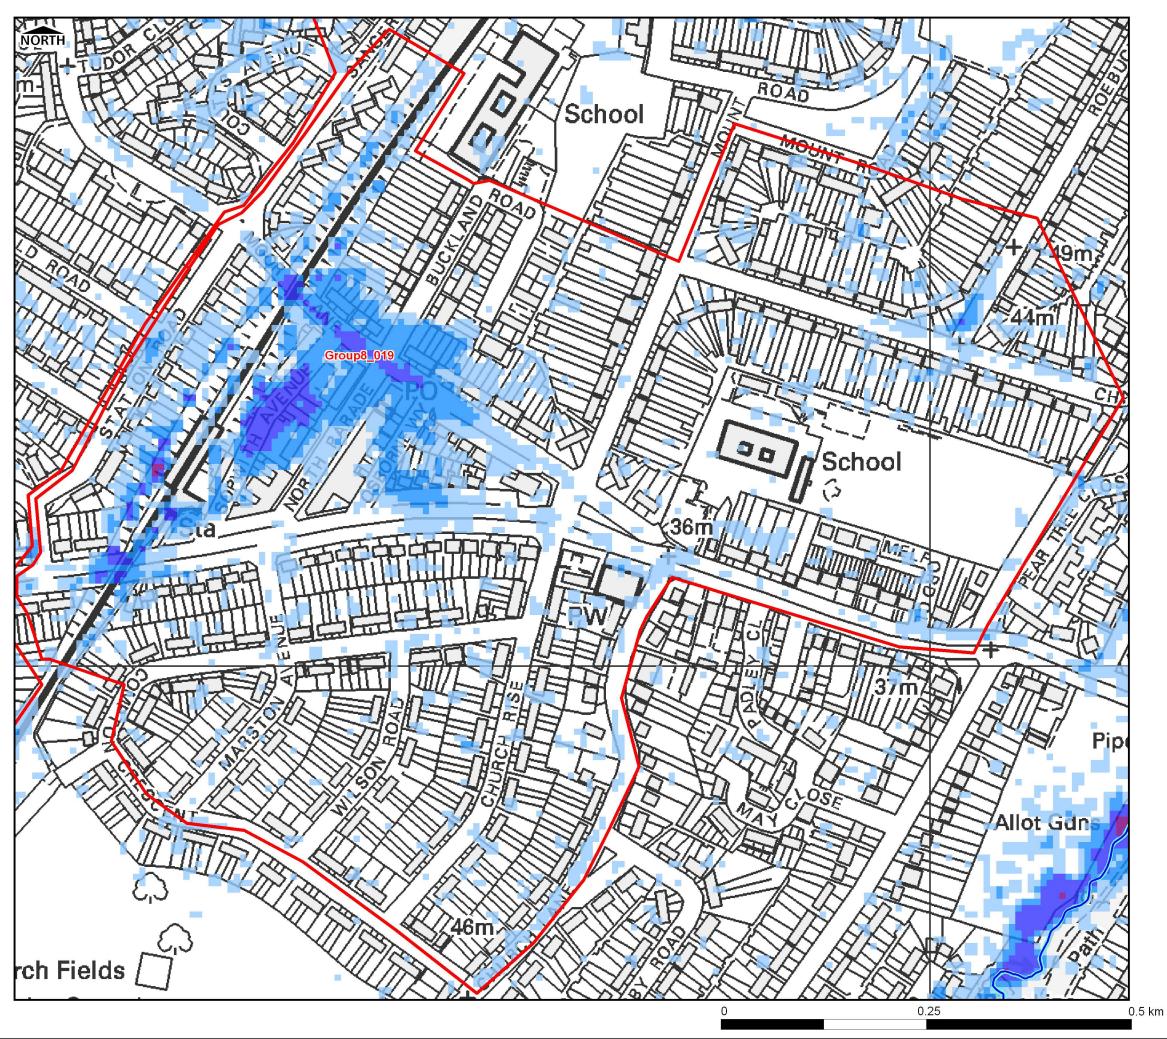
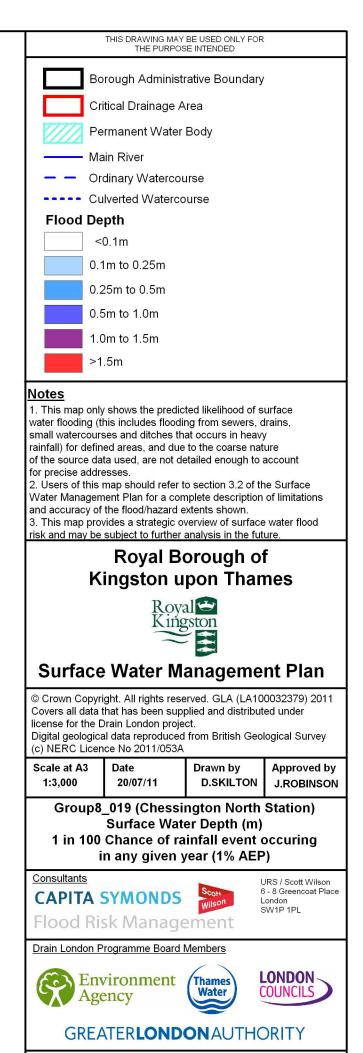
FIGURE 3.8.12a

• 0 non deprived households with basements are identified	
	with basements are identified to be at risk of flooding to a	
	to be at risk of flooding to a depth >0.5m	
	depth > 0.03m	
	There are no deprived households identified as being at risk within the	
	CDA	
Critical	There is one piece of critical infrastructure located within this CDA,	
Infrastructure	being an electricity substation on Compton Crescent	
Validation	The Council has no record of flooding at this location.	
Figures	Figure 3.8.12a – Surface Water Depth (1% AEP)	
	Figure 3.8.12b – Surface Water Flood Hazard (1% AEP)

3.8.37 This CDA is located in a topographical low point associated with the rail embankment. Surface Water from the south, north and east flows towards the railway embankment where water pools in the highway at Moor Lane and Bridge Road. The Royal Borough of Kingston upon Thames has no records of flooding at this location. The CDA is not identified to be in an area at increased potential for groundwater flooding. Thames Water records show 6-10 records of sewer flooding in the south of the Borough.
