COOMBE HILL INFANT SCHOOL
FLOOD RISK INVESTIGATION

PREPARED FOR THE ROYAL BOROUGH OF KINGSTON UPON
THAMES

Created by Emma Rowlands
Reviewed by Damon Reid-Williams
Approved by Michael Mair
Date December 2020
Version 1.2

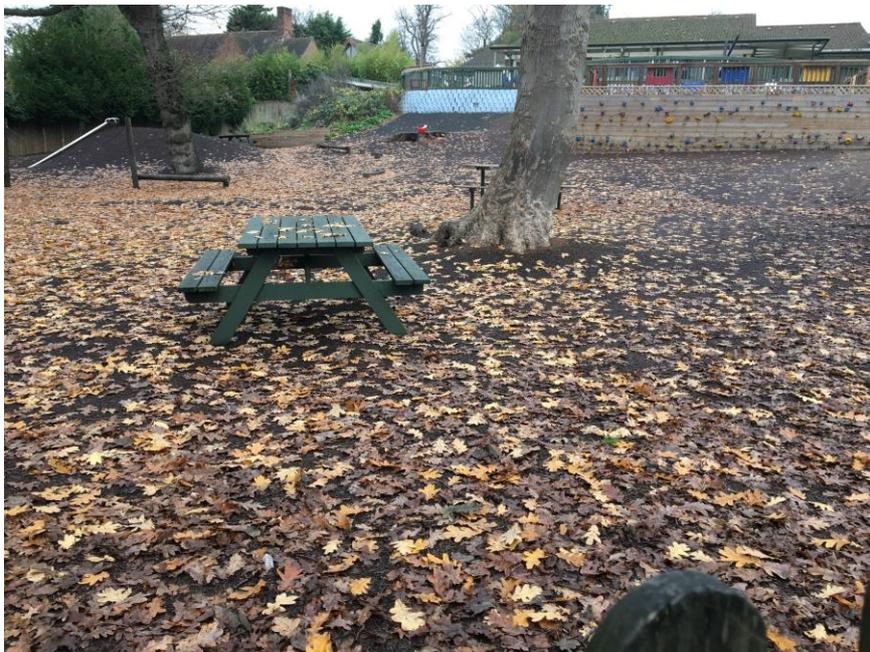
Figure 2.1 The Adventure Playground at the Coombe Hill Infant School site

Anecdotal evidence from the school's Site Manager describes springs appearing on the site infrequently. In February 2019, the Site Manager reported that this has occurred over several years and was able to be managed. However, in the few months prior to the Site Manager's February 2019 report, large volumes of water were appearing on the play area mulch on the Adventure Playground. This caused the mulch to increase in size and the flow of water to increase quite quickly. Where water was running underneath the play area mulch, it appeared as though the earth was being washed away creating a hollow underneath the Playground. A photograph of the Adventure Playground can be seen in *Figure 2.1*. Hydrological analysis of the six months prior to the flood report being received shows that there have been three storm events which approximate to at least a 1 in 5 year rainfall event (see *Chapter 3.2*).

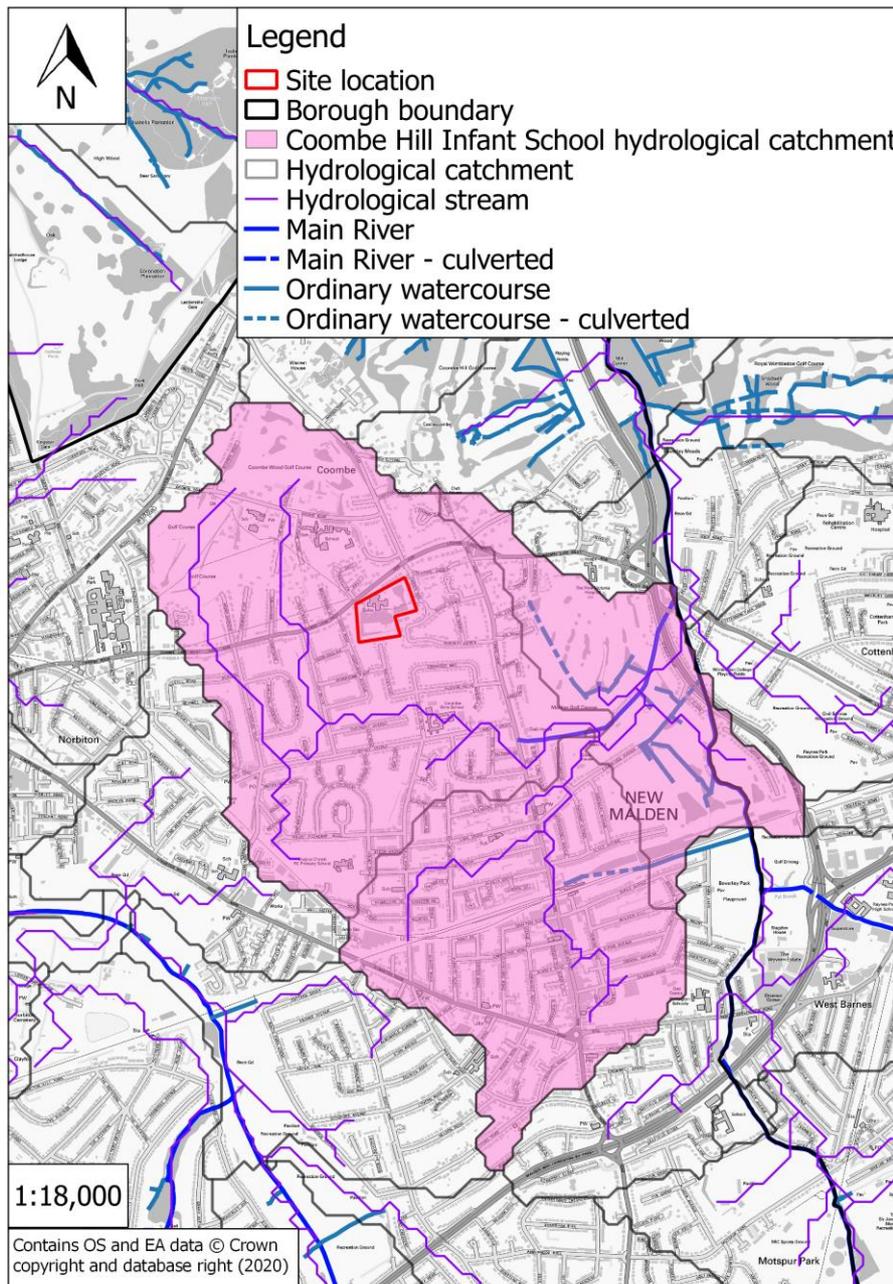
Figure 3.1 Hydrological catchment and primary flow path for Coombe Hill Infant School

Analysis of the area using a Geographic Information System provided several outputs, including defined hydrological catchments and primary flow paths (shown as 'Hydrological Stream' in *Figure 3.1*). The primary flow paths represent the main overland flow routes for surface water in the catchment. These flow paths appear to flow towards the east of the catchment, before combining and flowing into the Coombe Brook which is a tributary of the Beverley Brook. This suggests that rain falling on this catchment drains towards these flow paths. Further hydrological catchment and primary flow path information is presented in *Figure 3.1*.

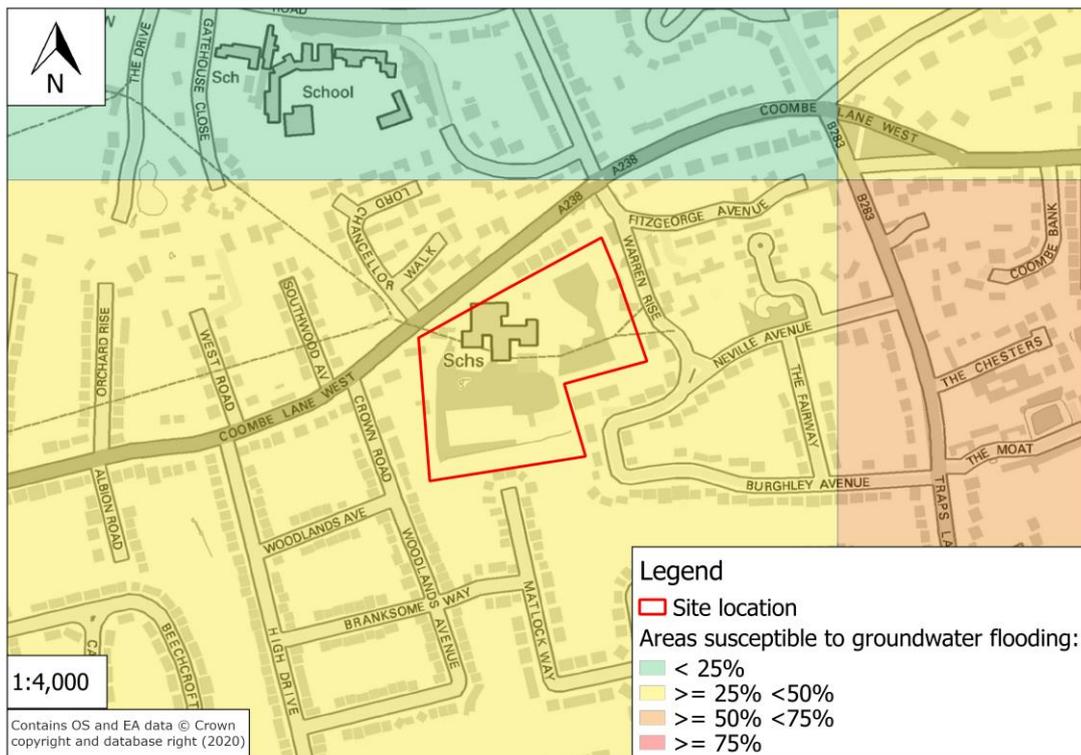
Figure 3.2 Areas susceptible to groundwater flooding

Based on the EA's *Areas Susceptible to Groundwater Flooding* data, Coombe Hill Infant School falls within a '>= 25% <50%' flood risk class. This is shown in *Figure 3.2*. Anecdotal evidence describes infrequent springs appearing at the site. Secondary A superficial and bedrock aquifers are located approximately 225m and 130m to the north of the site, respectively. These are shown in *Figure 3.3*. The bedrock geology at the location of both aquifers is Claygate Member. The bedrock geology is overlain by superficial deposits of Black Park Gravel Member at the location of the superficial aquifer. The geology at the site is London Clay with no superficial deposits. Between the southern extent of the superficial aquifer and the northern boundary of the site (a distance of approximately 225m), the topography reduces by approximately 16m. Between the southern extent of the bedrock aquifer and

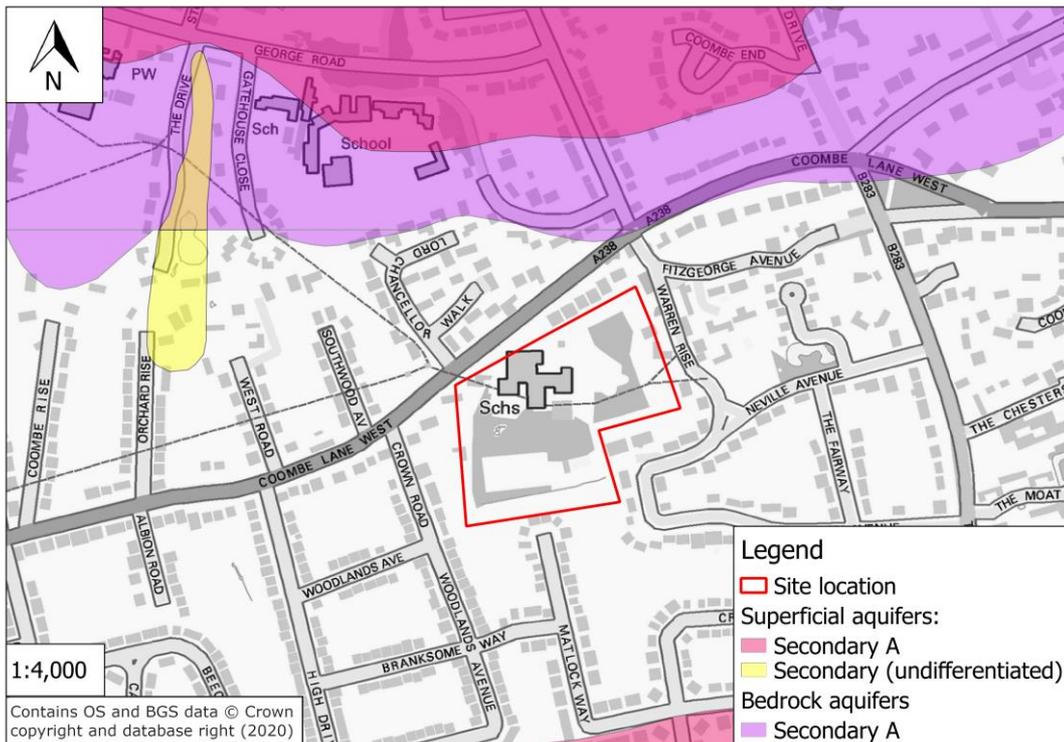
Figure 3.3 Aquifers at the Coombe Hill Infant School site

the northern boundary of the site (a distance of approximately 130m), the topography reduces by approximately 10m.

Due to the location of the aquifers upstream of the site and the steep topographical change, it is possible that water is travelling below the surface as throughflow towards the site. Throughflow occurs when the geology changes throughout a catchment with the change in topography. The upstream parts of the catchment tend to possess a productive aquifer and/or permeable superficial deposits, which change to unproductive and/or low permeable geology in the downstream parts. The geology in this location changes from a productive aquifer with permeable superficial deposits of Black Park Gravel Member in the upstream part of the catchment, to impermeable London Clay in the downstream part of the catchment. It is likely that there is a groundwater influence on the flooding issues at the Coombe Hill Infant School site.

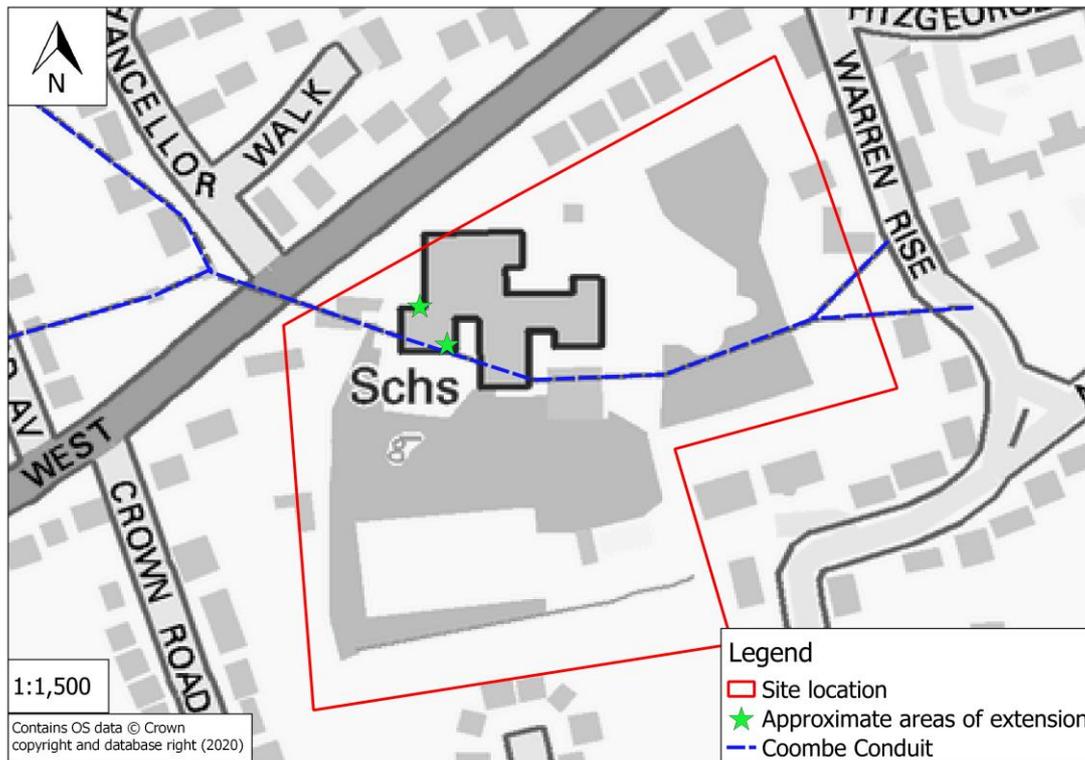
Figure 3.4 Approximate areas of building extension and Coombe Conduit

The Coombe Conduit runs underneath the school buildings. This is a pipe system which historically was used to transport water from springs in the Coombe area to Hampton Court Palace. It is no longer in operation, however there is a possibility that groundwater may be able to enter the remaining pipe work. Building work which took place at the school in 2015 may have altered any sub surface flows associated with the Coombe Conduit, potentially placing the site at greater risk of flooding from the

system. The approximate location of extensions to the school building in relation to the Coombe Conduit are shown in Figure 3.4.

- The LLFA should investigate who the owner of the Coombe Conduit is and who maintains it. They should also arrange for a survey of the Coombe Conduit to be conducted and determine what impact this has on sub surface flows on the school site.

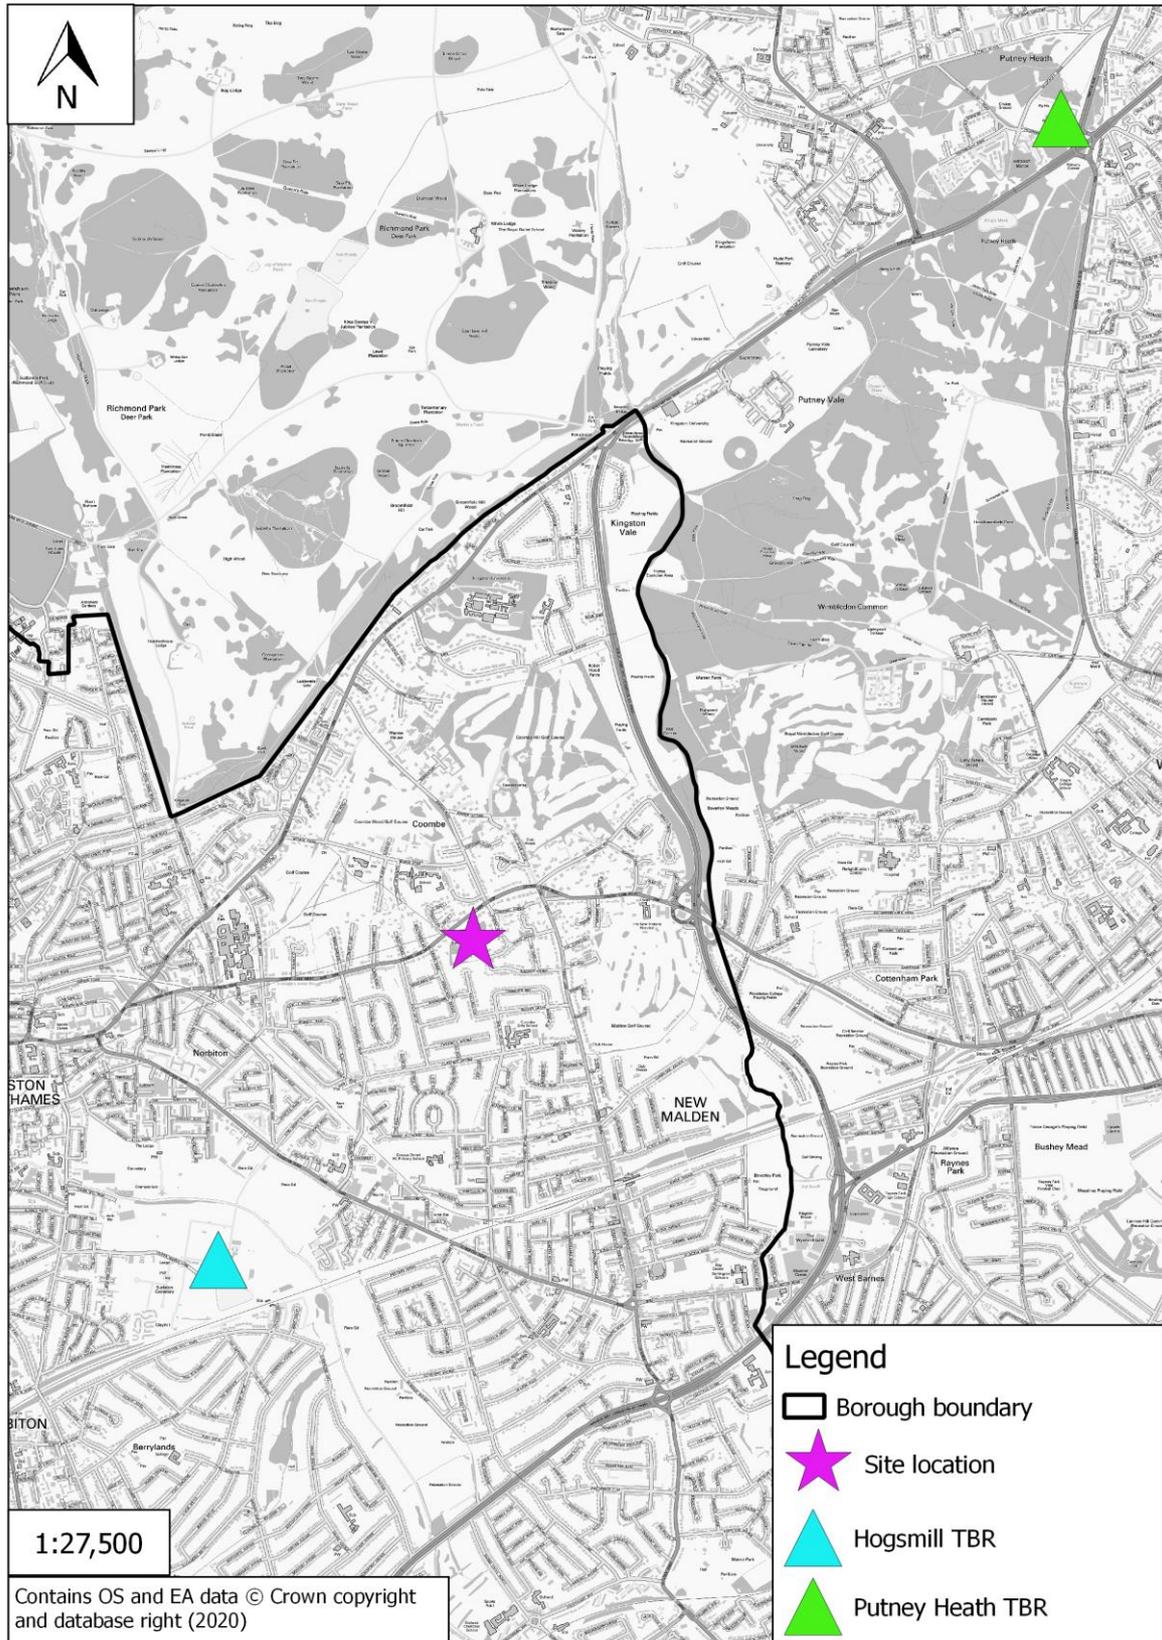
Figure 3.5 Location of the Putney Heath and Hogsmill TBRs

Rainfall data from a Tipping Bucket Raingauge (TBR) at Putney Heath was used to assess the reported rainfall event which resulted in flooding at the site. This is located approximately 5km north from Coombe Hill Infant School in the London Borough of Wandsworth (see *Figure 3.5* for approximate location). A TBR at the River Hogsmill lies within the Royal Borough of Kingston upon Thames and is located approximately 2km south west of the site. The recorded peak daily rainfall between the sites is comparable (both TBRs recorded similar amounts of rainfall on the three peak rainfall days in the six months prior to the flood event). Sometimes the Putney Heath TBR recorded a slightly higher amount in a day, other times it was the River Hogsmill TBR. The Putney Heath TBR was used in this instance.

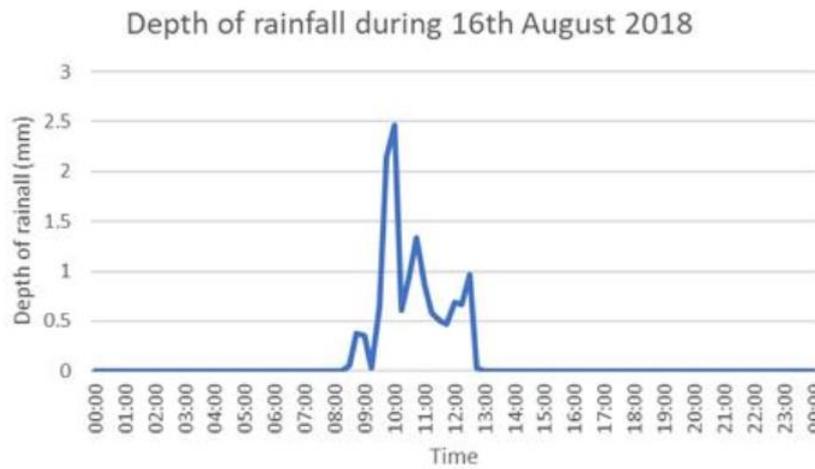
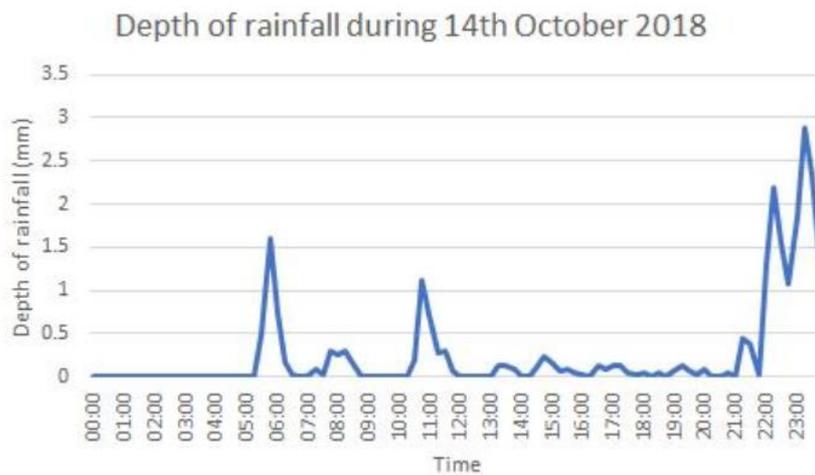
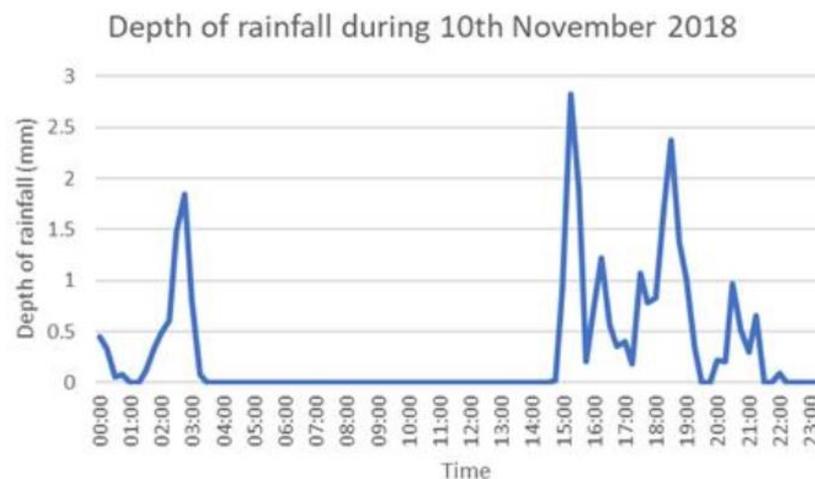
The data analysed from the Putney Heath TBR shows the variation in rainfall over a 24 hour period for three rainfall separate rainfall events. The Site Manager had confirmed that frequent flood issues over recent years had occurred leading up to the February 2019 flood event. Because the exact date of the flood events had not been recorded, three rainfall events were chosen between August 2018 to February 2019. The dates selected represent the heaviest recorded rainfall events over this period. No events from February 2019 were selected (the date of the flood event) because there were no days where the daily rainfall exceeded 8mm. The data recorded at the TBR provides accumulated totals for each 15-minute period. *Table 3.1* provides a summary of the three rainfall events investigated as part of this study. Rainfall event specific details on rainfall variation are shown in *Figure 3.6*, *Figure 3.7*, and *Figure 3.8*.

The data for the 2018 events indicates that the peak rainfall return period for the three flood events approximates to a 1 in 5 year event (20% probability of a rainfall of that intensity occurring in a given year). As highlighted in *Chapter 2*, Coombe Hill Infant School is situated in a topographical low point compared to the land immediately to the north of the site. In addition, anecdotal evidence suggests that runoff from the main road flows towards the school buildings in the north of the site. Further anecdotal evidence states that large volumes of water were appearing on the play area mulch on the Adventure Playground. This caused the mulch to increase in size and the flow of water to increase quite quickly. Based on the identified flood risk sources and the nature of flooding that has occurred on the site, it is possible that the flood events are greater than 1 in 5 year events.
